Carlton Street Footbridge – Update May 2023

Restoration of this 1894 Carlton Street Footbridge (CSF) connecting Brookline's Longwood neighborhood with Riverway Park in Olmsted's Emerald Necklace should be complete within a month.

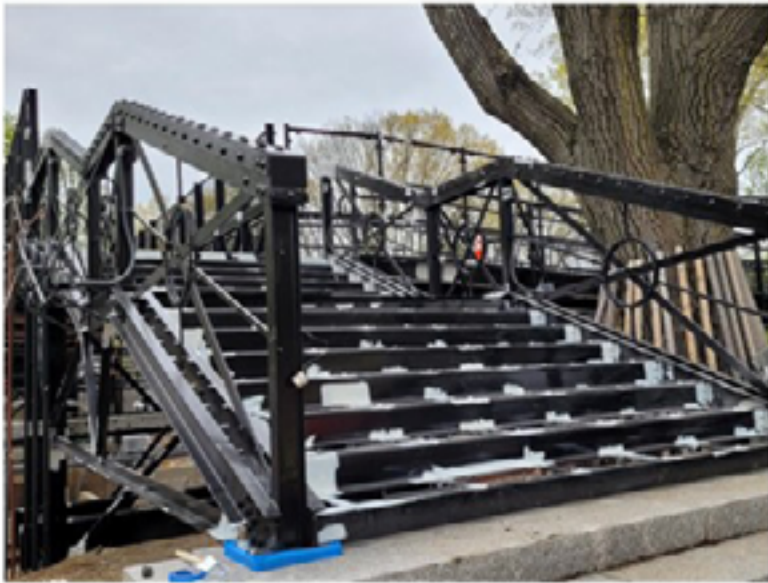
Final touchup of paint starts with a 2-part epoxy primer. The final coat, also a 2-part epoxy, is then applied.

In 2010, samples were removed from north side stairway surfaces that had been protected from weathering. These were analyzed microscopically to match the original paint.

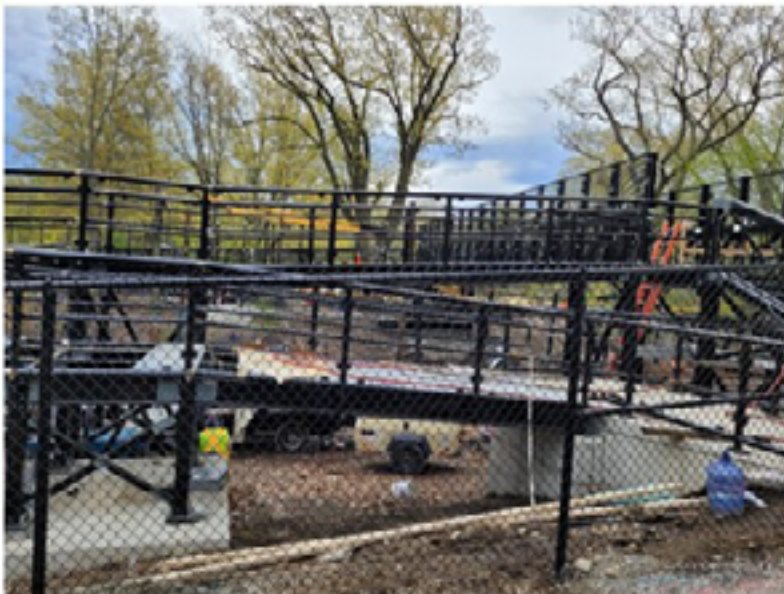
120' of 6'-wide ramp is installed on the park (south) side and 91' on the street (north) side. Railings are welded and primed before final painting.

A total of over 1,600 square feet of aluminum grating is used for the ramps.

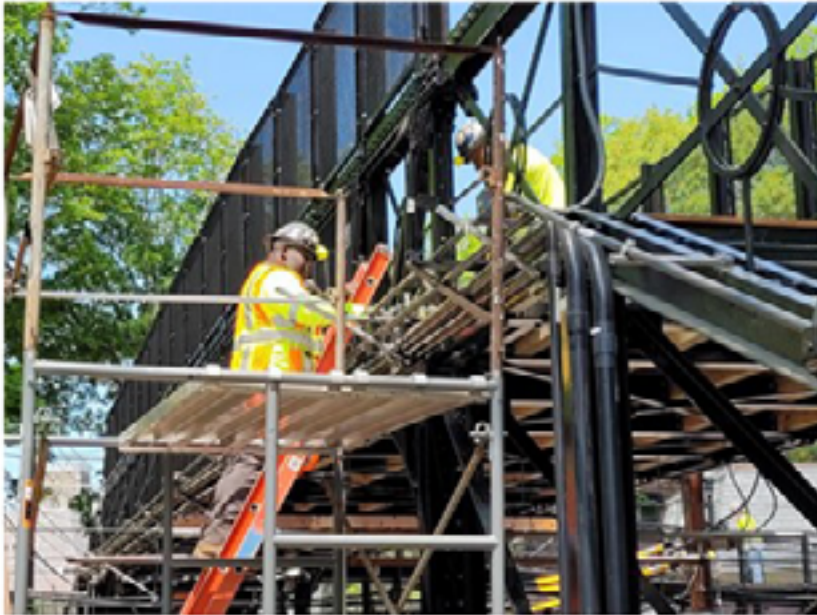
An Aetna worker installs conduit for the electric line that will power the light fixture and police call box in the park.

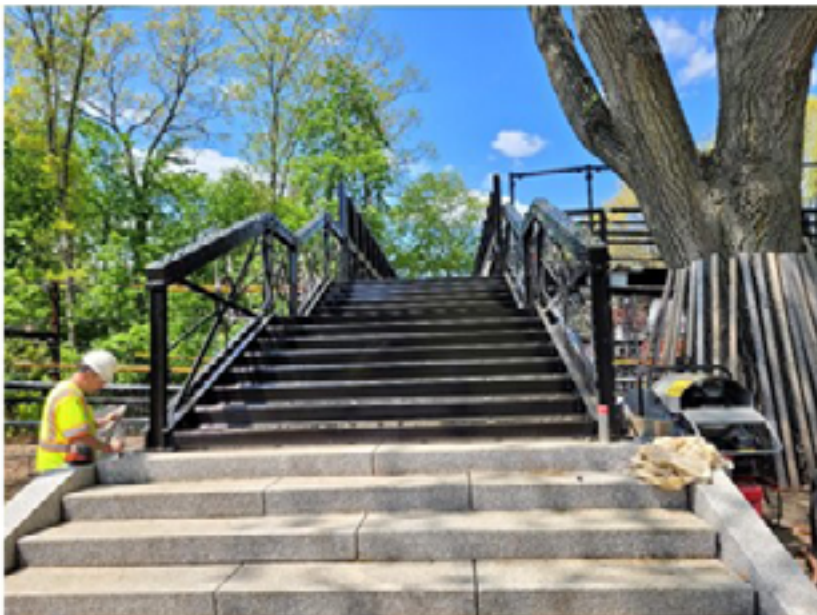
Granite steps lead to the restored stairway. Grout will be applied to all the seams to guard against moisture.

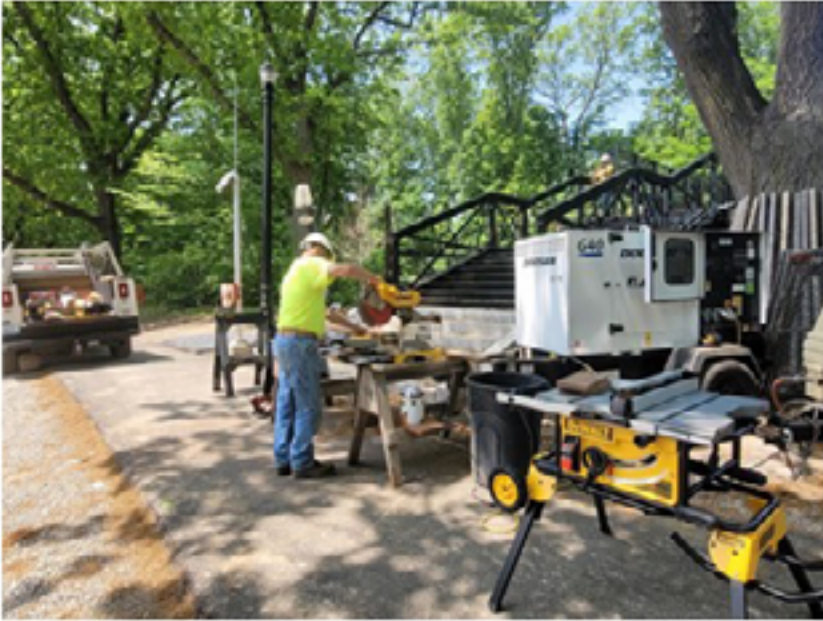
An Aetna carpenter starts to cut the board for the decking, tread and risers.

These are being constructed using ipe, (pronounced e-pay), a teak-like Brazilian hardwood known for its durability and insect resistance.

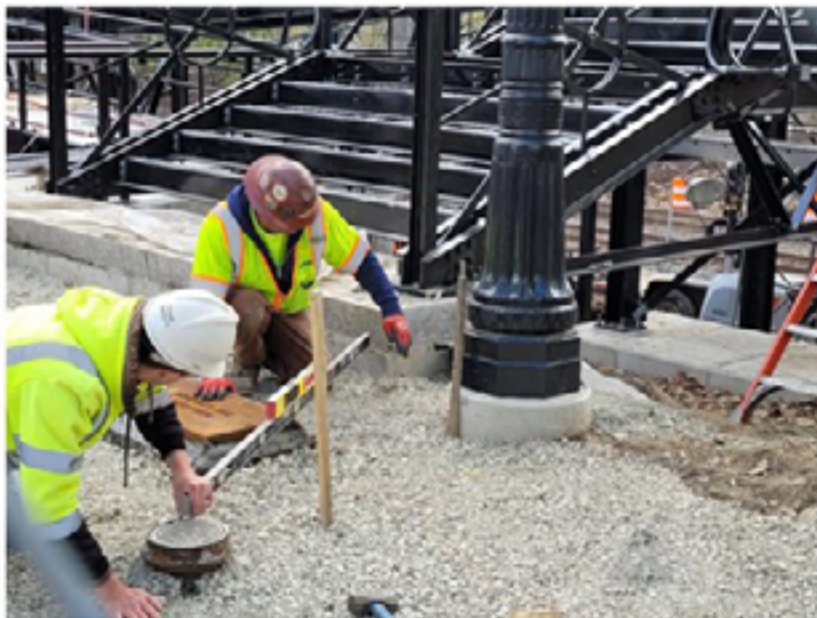
“Measure twice, cut once”. On the Carlton Street side, the concrete pavement must slope to allow proper drainage and prevent ice.
