## Carlton Street Footbridge – Update Feb. 2023

This is the last major component of the historic 1894 bridge over the Riverside "D" line MBTA track which has been restored over the last 1.5 years. Steps, landscaping and pavement will be installed this spring, with opening expected by June.

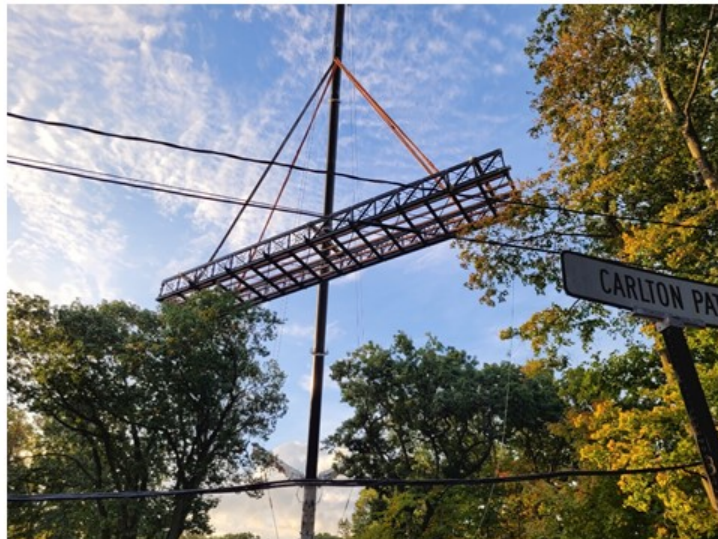
Main span is lifted high above the oak trees into place. October 2022

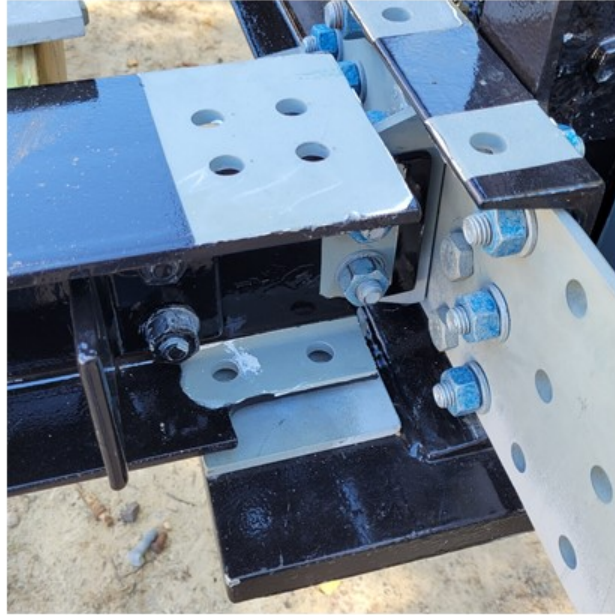
Reconstruction is complex. In Coventry RI, all the pieces must be labelled, welded, tested for strength, holes drilled for new  $\frac{3}{4}$ " galvanized bolts, sandblasted to remove rust, primed, coated with an epoxy paint, and a coat of urethane added for weather resistance.

Then it all has to fit when installed on site in Brookline.

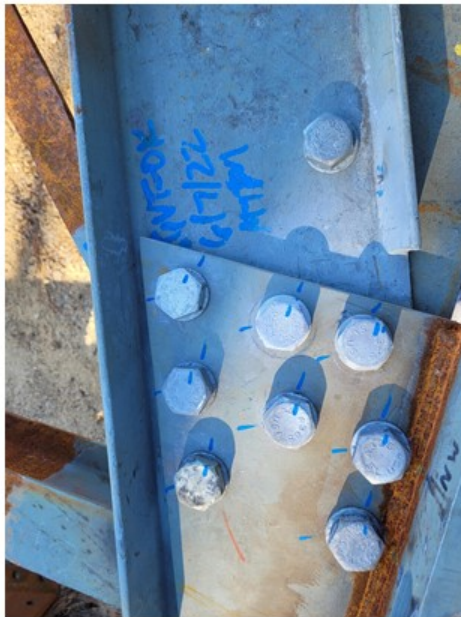
Bolts must be installed and "torque tested", indicated here by the blue lines on the bolt heads.

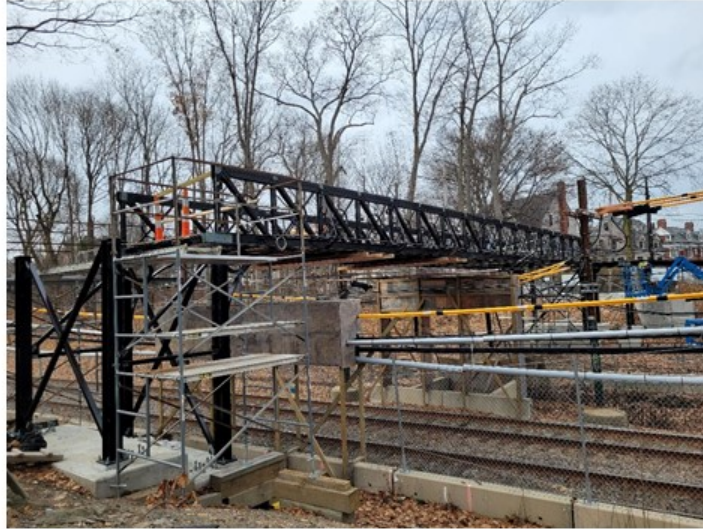
Main span in position awaiting installation of ramps and stairways. This restoration is about 2' higher to meet MBTA requirements. The bridge has been lengthened to accommodate the insertion of 6'-wide ADA ramps on each end,

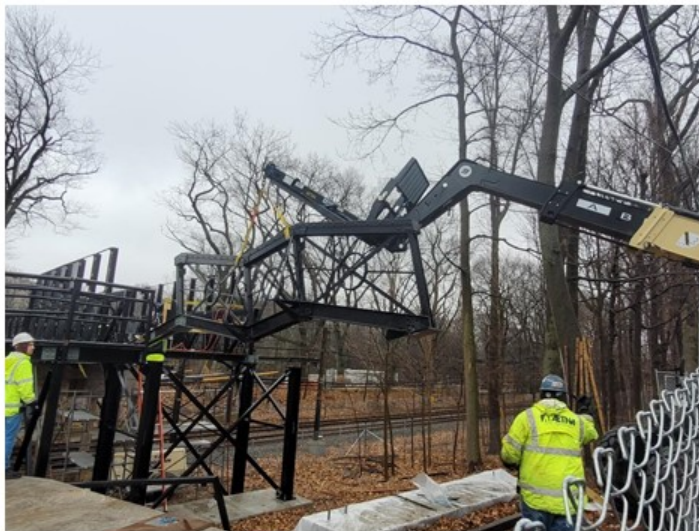
A large forklift maneuvers part of the north (Colchester Street) stairway into position
