Carlton Street Footbridge (CSF) Restoration Update – Sept. 17, 2021

Summer is over, progress continues. Concrete forms on the park side are almost completed.

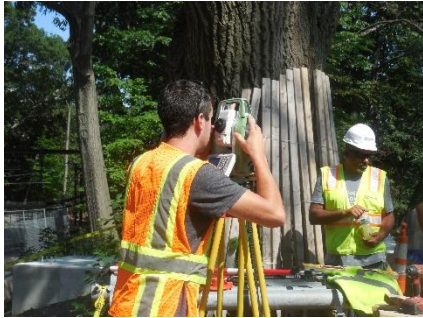
Project Site Manager for Aetna Bridge Co. double-checks the alignment for the cement steps soon to be poured.

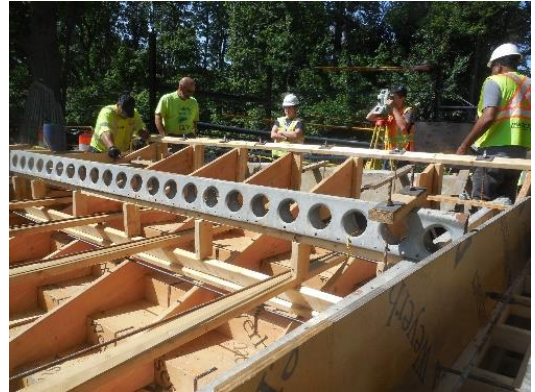
Wooden forms have been constructed for the park side steps.

Rebar (reinforcing bar) is used to increase the tensile strength of the concrete, helping to resist cracking and breaking.

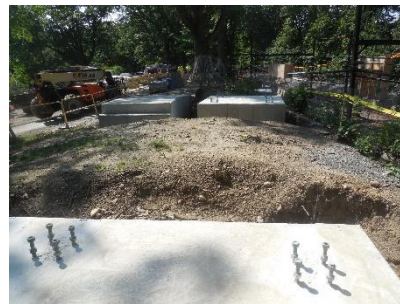
Extensive ramps will be supported by concrete forms which have already been constructed on the park side.

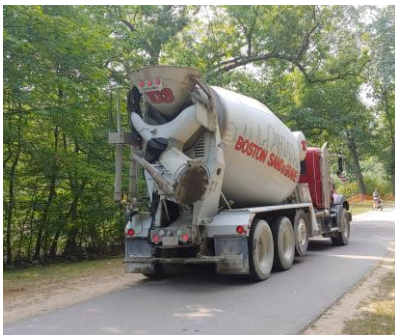
The first of 3 trucks arrives with 10 cubic yards of cement for the park side steps.

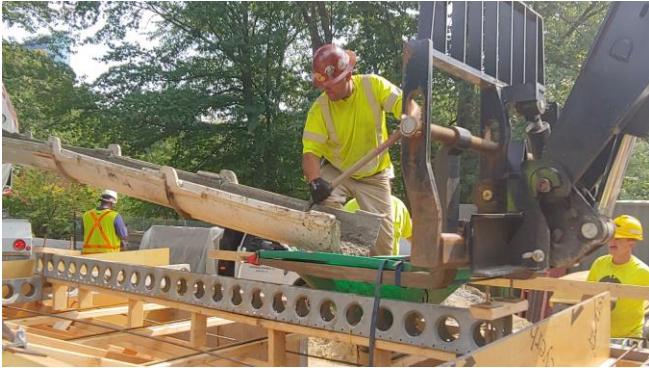
The chute is in place, and the concrete slurry is running. A total of 22 cubic yards will be used for the steps. Excess mixed concrete may be used for Jersey barriers.

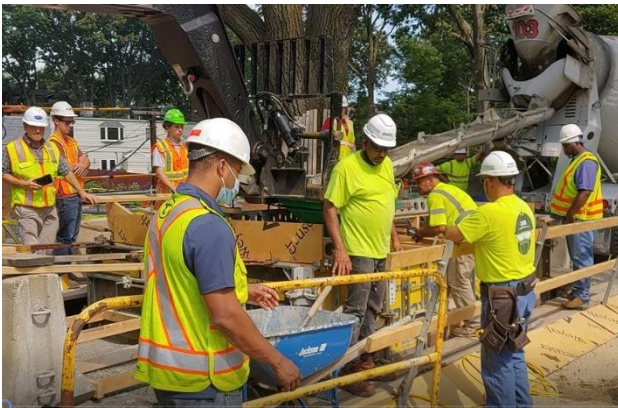
Pouring the wet concrete is a team effort – Aetna Bridge Co., MassDOT, and Brookline Engineering all join in the effort.

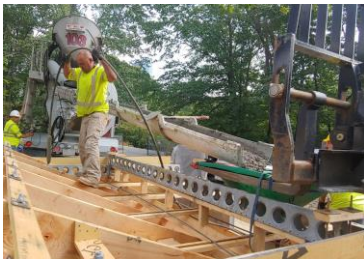
A concrete vibrator is lowered into the wet concrete. This will remove air bubbles which, if not removed, can compromise the cement's longevity and strength.

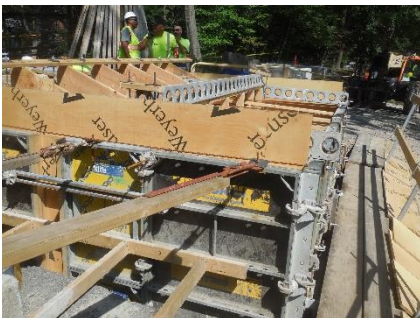
“Doka” steel concrete forms will be removed in about a week, exposing the finished 13-foot wide stairway..
